STUDY OF STABILITY PROBLEMS AND HAZARD EVALUATION IN THE MISSOURI PORTION OF THE TRI-STATE MINING AREA

Contract J0100132
Missouri Department of Natural Resources
Division of Geology and Land Survey

BUREAU OF MINES
UNITED STATES DEPARTMENT OF THE INTERIOR

REPORT DOCUMENTATION PAGE		1. REPORT NO.		2.		3. Recipient's Accession No.	
4. Title and Subtitle Study of Stability Problems and Hazard Evaluation in the Missouri Portion of the Tri-State Mining Area						5. Report Date April 30, 1983

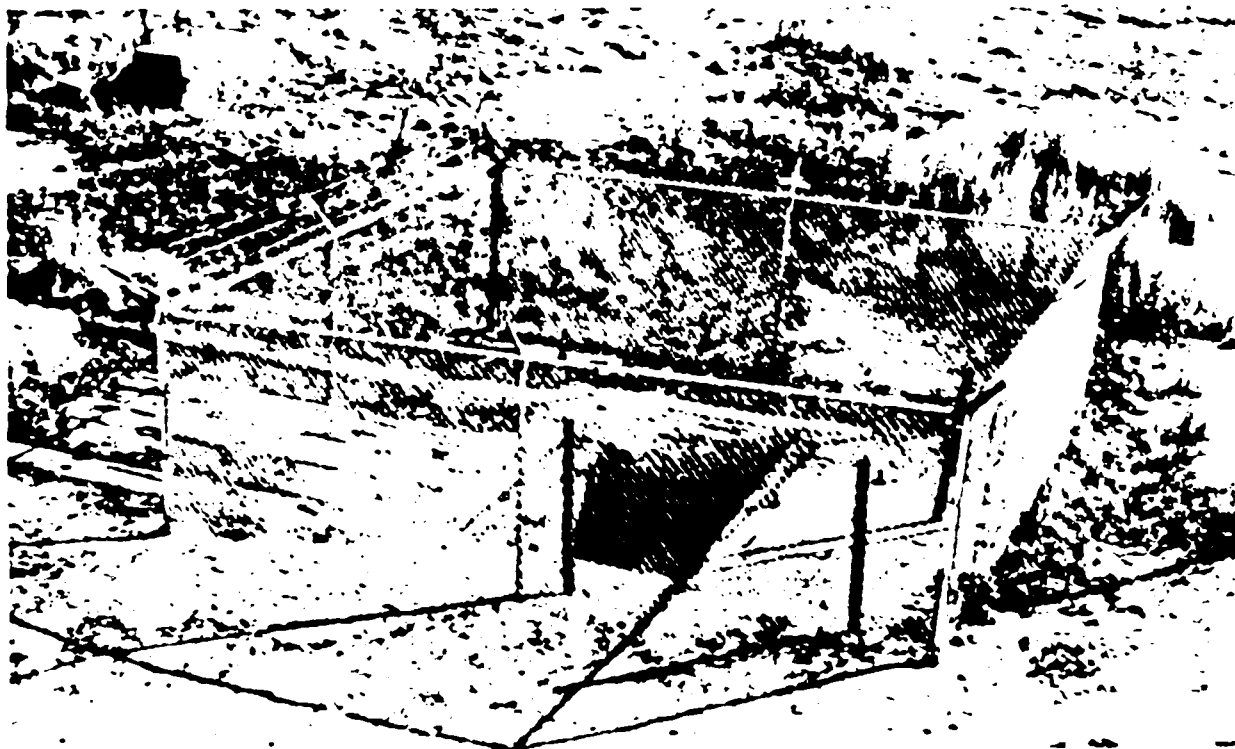
FIGURE 17. -- Open shaft, safeguarded with metal fencing.

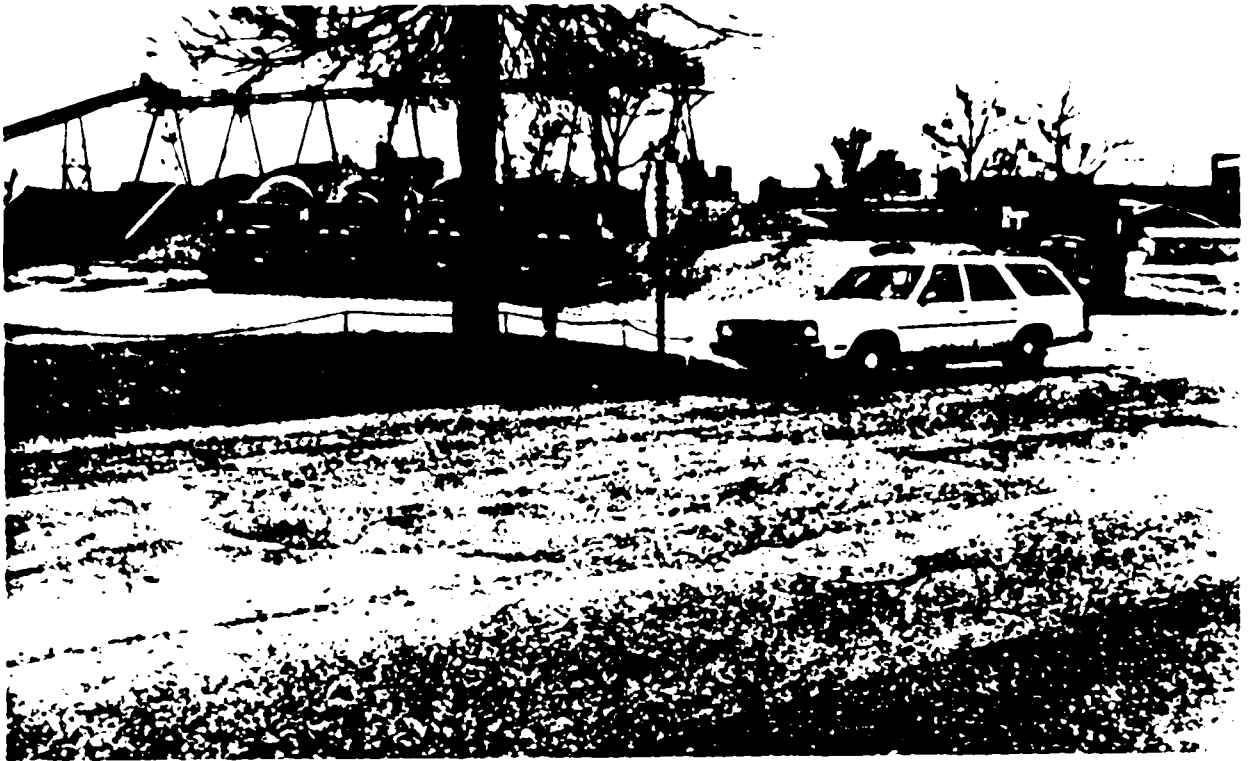
FIGURE 22. — Repaired subsidence in roadbed, Murphy and 5th Streets, Joplin.

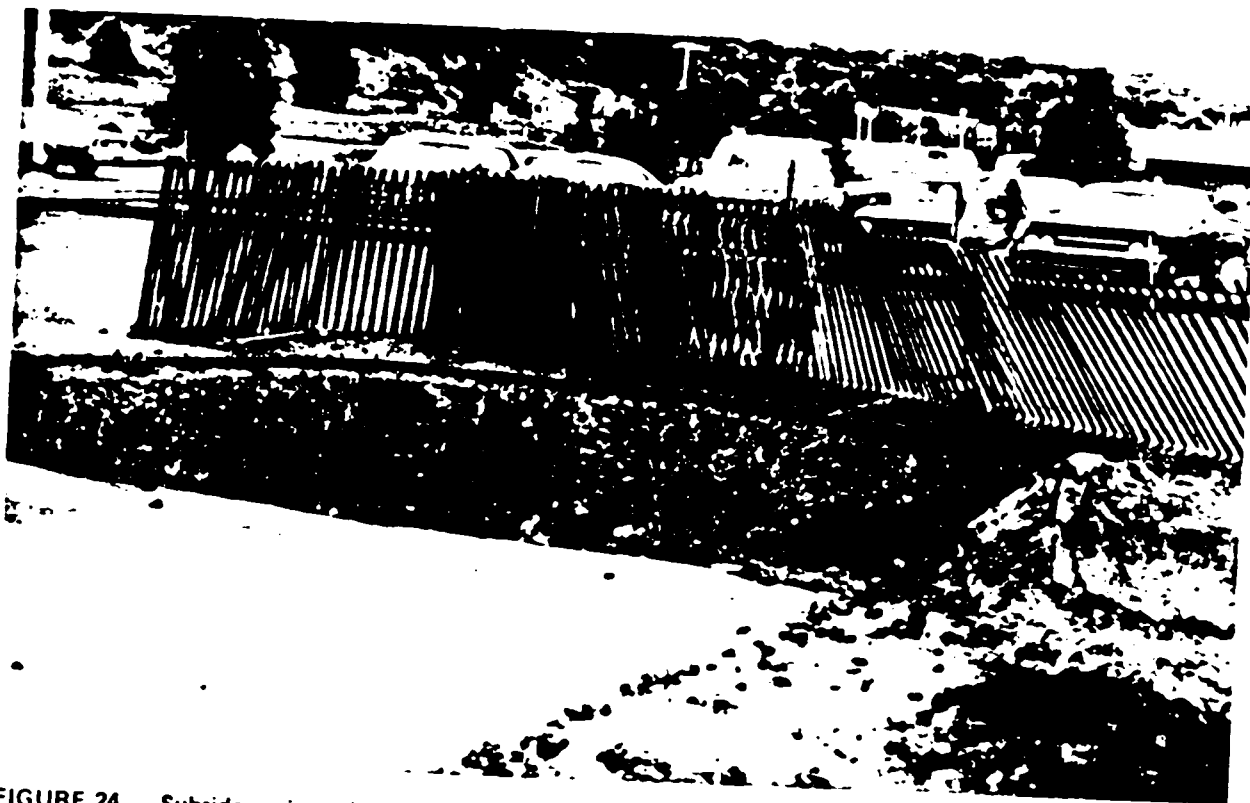
subsidence occurred on June 1, 1982, in the parking lot of the St. John's Regional Medical Center (site number 27-33-15-3). The resulting hole was 20 m (60 ft) deep and filled with water to within 6 m (20 ft) of the surface. The oval-shaped surface outline, measuring 3 x 6 m (10 x 20 ft), is shown in figure 24. A fill of rock and concrete mix has temporarily sealed the opening at this site (fig. 25). It is apparent that this area holds a high potential for future, subsidence-related problems.

FIGURE 24. — Subsidence in parking lot at St. John's Regional Medical Center, Joplin.

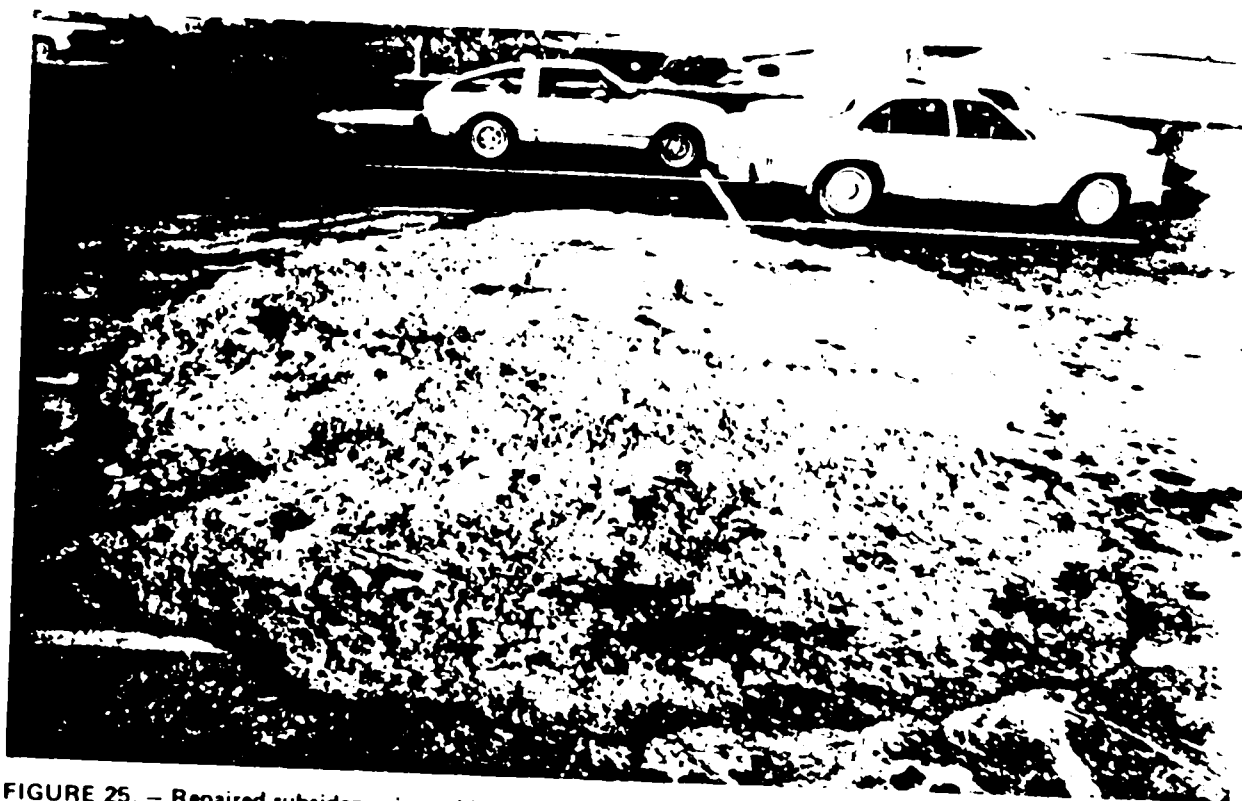
FIGURE 25. — Repaired subsidence in parking lot at St. John's Regional Medical Center, Joplin.
